SUBARU

SERVICE BULLETIN

APPLICABILITY: All Models
SUBJECT: Cylinder Head Gasket (residual carbon deposits and rubber coating removal)

NUMBER: 02-100-06R
DATE: 10/31/06

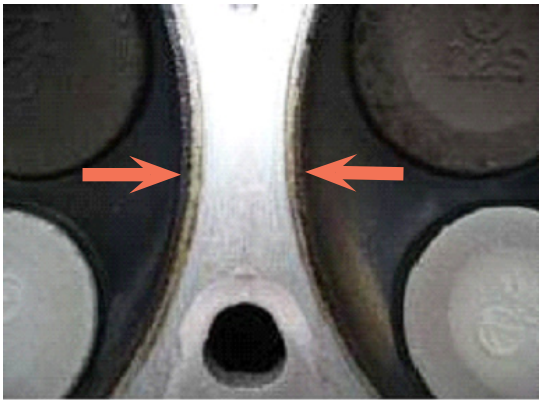
Accumulated carbon deposit on
bore sealing portion

Using a gasket scraper, carefully clean any carbon deposits and rubber coating found on the surface of cylinder block and cylinder head.

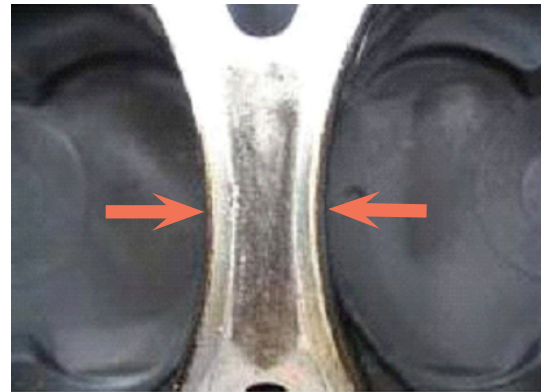
Carbon deposit on cylinder block
bore sealing portion

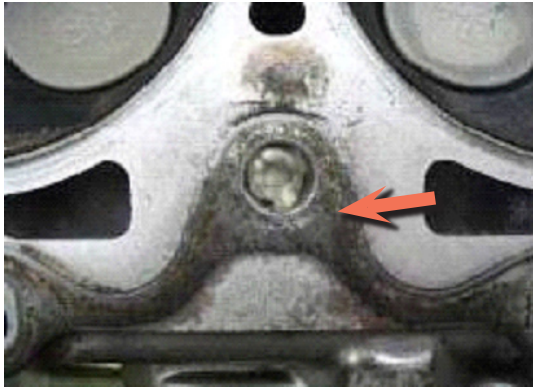
Rubber coating residue on coolant sealing portion

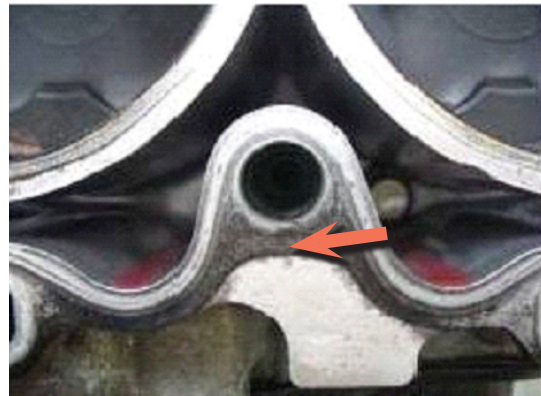
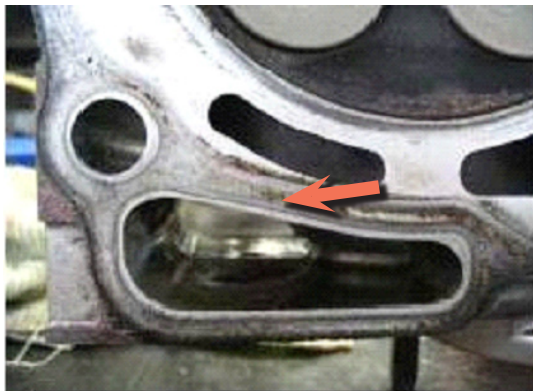
Rubber coating residue on oil sealing portion
