SERVICE BULLETIN

APPLICABILITY: 2000MY and Later Legacy/Outback
 2.5L SOHC Vehicles
 1999MY and Later Impreza and
 Forester 2.5L SOHC Vehicles

NUMBER: 07-60-07R
DATE: 04/25/07

SUBJECT: Ignition Coil and High Tension Cables

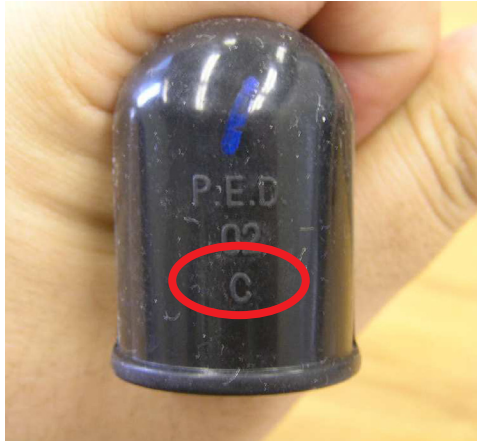
The high tension cables for Impreza and Forester have changed to a silicone rubber boot which has a shiny appearance. Please note that the part numbers have not changed. The Legacy and Outback high tension cables also have a silicone rubber boot.

New Style (C)

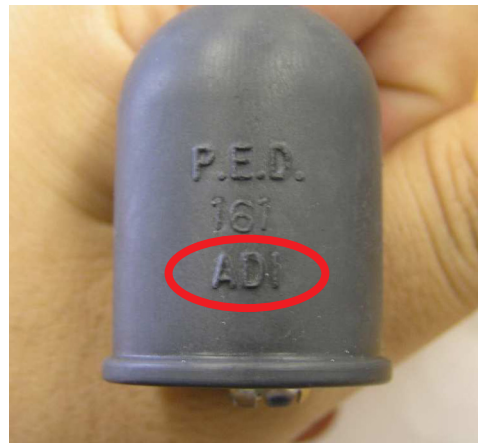
Old Style (ADI)
