SERVICE BULLETIN

APPLICABILITY: Legacy, Impreza and Forester Vehicles **NUMBER:** 02-93-04
SUBJECT: Modification of Timing Belt Tensioner **DATE:** 11/05/04
 Bracket

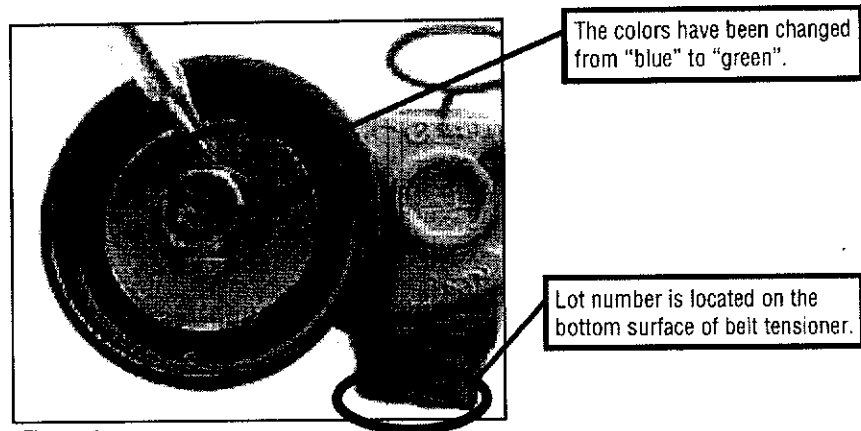
Figure 1

The color of the paint dot on the pulley bolt was changed from "Blue" to "Green" (see Figure 1)
Lot number of belt tensioner: 020402 and after.

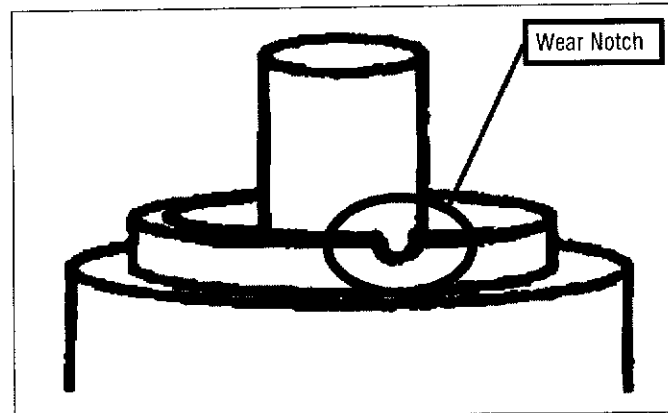
Figure 2

- (2) Confirm if the noise is coming from the upper portion of the timing belt tensioner by using a stethoscope. If noise can be heard it's either coming from the tensioner or bracket. Inspect the belt tensioner; if the cylinder body of the timing belt tensioner has a notch from wear (see Figure 2) the tensioner will need to be replaced.

- (3) If the engine number is 572570 for SOHC or 572928 for DOHC and after, replace the timing belt tensioner bracket.
- (4) If the engine number is 572570 for SOHC or 572928 for DOHC and before, check to see if the cylinder body of the timing belt tensioner has a wear notch. If so, replace the timing belt tensioner. If the cylinder body of the timing belt tensioner does not have a wear notch, replace the timing belt tensioner bracket.
